TEST REPORT

TRENWA LHF 26" - 60" Composite Trench Panel AASHTO M306-04 H20 Test

Document reference number - FIB-TRENWA 26-60-15-05-15

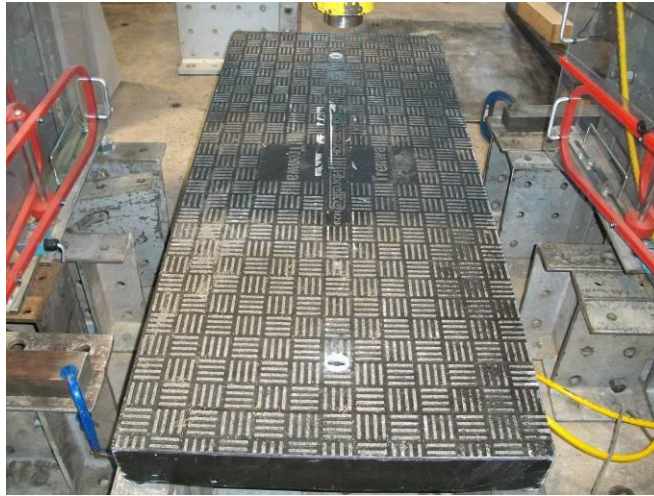
Photo. 1

The composite trench panel supplied is a rectangular TRENWA LHF 26" - 60". (Photo.1)
Panel size - 60" x 26" x 4" (1523mm x 660mm x 102mm)

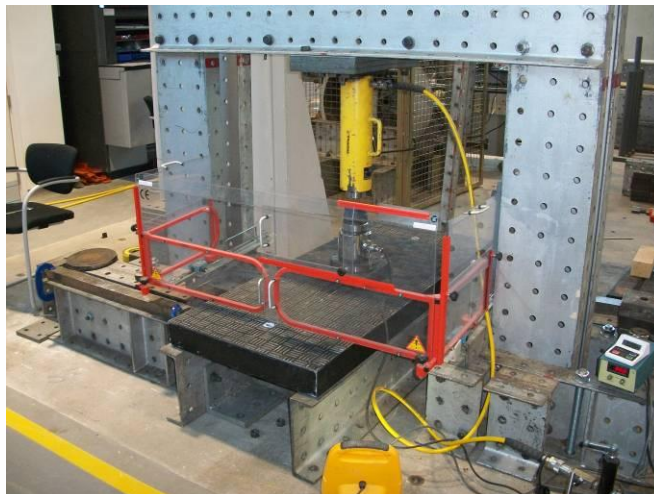
Photo. 2

The test rig consists of a 'giant mecano' frame bolted to the floor and supporting the Enerpac 50 ton hydraulic cylinder. (Photo 2)

The panel was supported on steel channels along the sides giving a span of 20 inches.

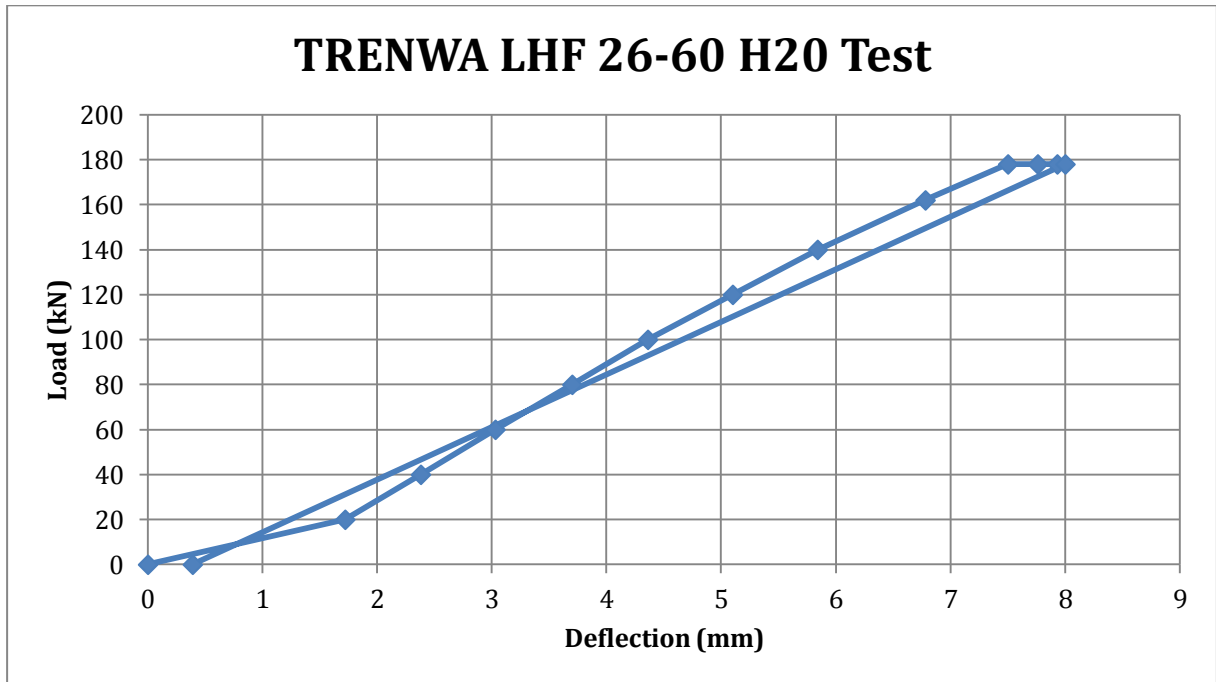
LOAD		DEFLECTION		REMARKS
(kN)	(lbs)	(mm)	(in.)	
0	0	0.00	0.000	
21	4,720	1.72	0.068	
40	8,992	2.38	0.094	
60	13,488	3.03	0.119	
80	17,985	3.70	0.146	
100	22,481	4.36	0.172	
120	26,977	5.10	0.201	Odd light cracking noise from here on.
140	31,473	5.84	0.230	
162	36,419	6.78	0.267	
178	40,000	7.50	0.295	
178 (20 seconds)	40,000	7.76	0.305	
178 (40 seconds)	40,000	7.93	0.312	
178 (60 seconds)	40,000	8.00	0.315	PASS
0	0	0.39	0.015	
230	51,706	Dial gauge removed		Louder cracking
294	66,094	-		Ultimate failure

The panel held the proof test load of 40,000 lbs (178kN) for the required 1 minute and with no visible signs of any cracking.

In accordance with Clause 5.1 of the AASHTO M306-04 standard the permanent deformation was 0.015 in. (0.39mm) and is within the 1/8 in. (3.2mm) that is allowed.

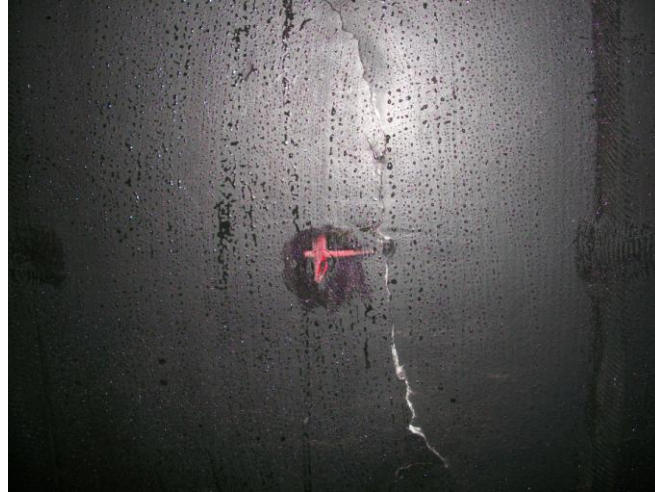
Photo.3

On inspection a large crack had appeared on the underside around the centre of the panel. (Photo.3)

After the panel had passed the H20 test the dial gauge was removed from under the panel to avoid damage and the panel loaded until failure occurred at 294kN.
