# TEST REPORT

**TRENWA Eco-lite  
LHE-46-30 Load Test No.2  
Span - 40"**

Document reference number - FIB-TRENWA-46-30-2-24-01-20

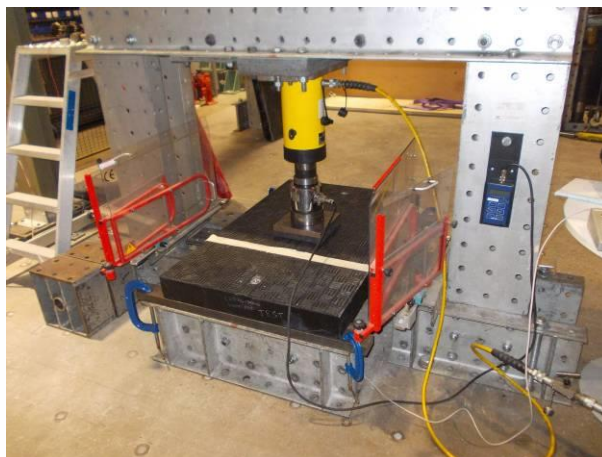
Photo. 2

The test rig consists of a 'giant mecano' frame bolted to the floor and supporting the Enerpac 90 ton hydraulic cylinder. (Photo 2)

**The panel was seated on 65mm x 50mm rectangular steel bars at a clear span of 40 in. (1016mm).**

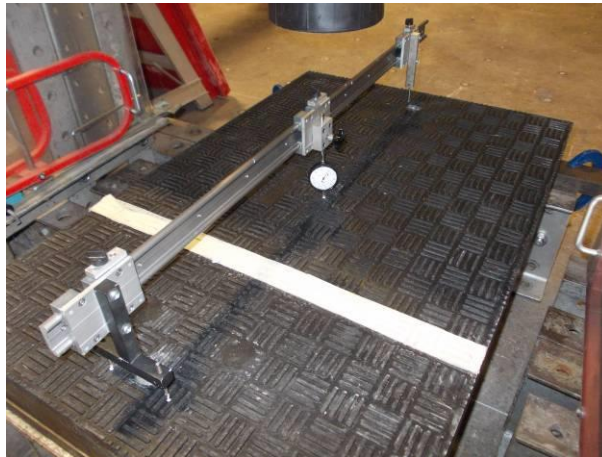
Photo.4

Initial Reading	0.00mm	
Reading after 20,800lbf held for 1 min.	0.74mm	
<b>Permanent Set</b>	<b>0.74mm</b>	<b>.029in.</b>

Permissible permanent set required for the test is 3.2mm (1/8in.)

**Therefore panel passes the permanent set test.**
